**STUDY OF EROSION MECHANISMS
OF ENGINEERING CERAMICS**

Sixth Interim Technical Report
April 1 to July 31, 1977

Solar Turbines International
an International Harvester Group
San Diego, California

RDR 1778-8

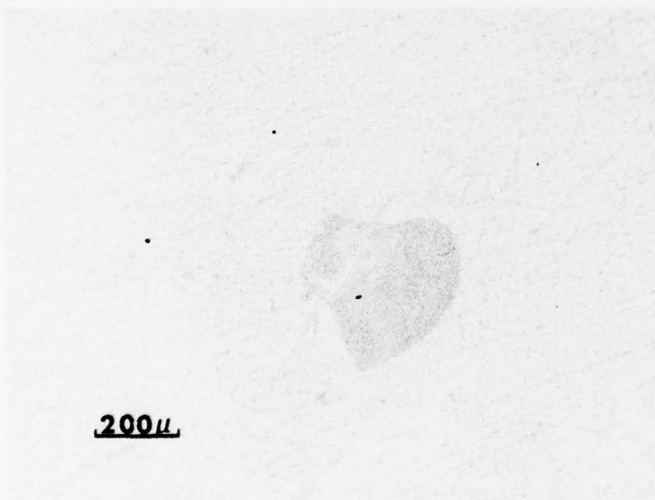
- a. Hot Pressed MgF_2 Impacted
With 273μ Quartz
188 m/sec Velocity
Contact Radius $\sim 27\mu$
(3 impacts)

- b. Hot Pressed Si_3N_4 Impacted
With 305μ SiC
176 m/sec Velocity
Contact Radius $\sim 22\mu$

Figure 3. Single Particle Impacts for Systems Which Exhibit Consistent Particle Size-Velocity Functions With Erosion (Sheet 1 of 2)

Surfaces were examined for a range of erosion conditions varying between single particle impacts and erosion to a depth of several grain diameters for the various particle size velocity test conditions. Generally, the heavily eroded surfaces were sufficiently damaged that little information was provided concerning erosion mechanisms or processes. However, single particle impacts have provided insight into the process of erosion for these target materials. Figure 3 shows examples of single particle impacts for those target-particle combinations which exhibited a consistent particle-size velocity dependence. The types of impact are typical for each system although magnitude varied with particle size and velocity. The contact areas estimated for purely elastic impact by a spherical particle are given to illustrate variations in damage magnitude. HP Si_3N_4 impacted with SiC particles and MgF_2 impacted with quartz particles (Fig. 3a and 3b) both exhibited plastic impact accompanied by radial and lateral crack formation. The radial cracks extend outward from the particle contact zone and are generally perpendicular to the surface. Lateral cracks also extend from the contact zone but are subsurface and approximately parallel to the surface. This type of impact damage has recently been observed in other systems (Ref. 2). Material removal occurs by loss of a portion or all of the laterally cracked regions. The dark semicircular regions in Figures 3a and 3b correspond to laterally cracked material which has been removed during impact. Also shown in Figure 3a by polarized light reflecting conditions are the lateral cracks which have not resulted in material loss. Since HP Si_3N_4 is opaque, subsurface cracks are not observable by the polarized light technique. For these two systems, the extent of damage or material loss is much larger than the particle contact area.

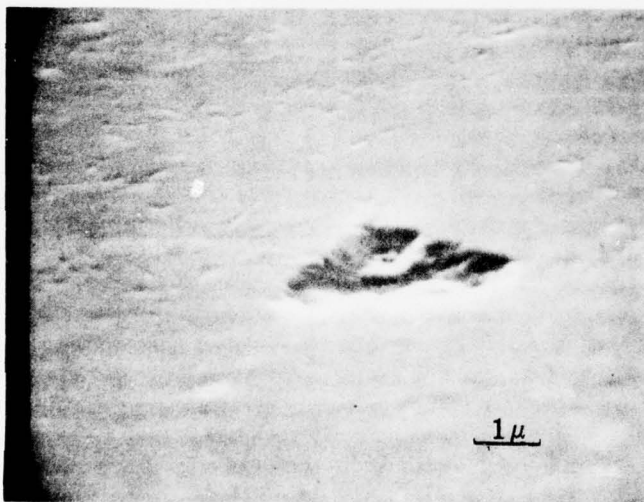
c. Reaction Bonded Si_3N_4
 Impacted With 385μ Quartz
 174 m/sec
 Contact Radius $\sim 35\mu$

d. Hot Pressed Si_3N_4 Impacted
 With 273μ Quartz
 188 m/sec Velocity
 Contact Radius $\sim 25\mu$

Figure 3. Single Particle Impacts for Systems Which Exhibit Consistent Particle Size-Velocity Functions With Erosion (Sheet 2 of 2)

Figure 3c shows a quartz particle impact on RB Si_3N_4 . The impacts in this system are characterized by relatively deep pits with no apparent evidence of secondary cracks intersecting the surface. The approximate calculated contact radius ($\sim 35\mu$) is of the same order as the pit. The appearance of the pit is one of plastic impact. However, since this material is inherently porous ($\sim 25\%$), the phenomena could be one of crushing rather than plastic deformation. This porosity might also be expected to arrest crack propagation which would occur in a fully dense material. The type of impact

damage shown in Figure 3c is characteristic of the RB Si_3N_4 quartz particle system except for the smallest particles (10μ) where single impacts could not be differentiated from the inherent porosity. Examination in cross section revealed radial cracking beneath the contact area that propagated through the pores.

The type and magnitude of damage produced by quartz particles on HP Si_3N_4 is entirely different from that of the three systems previously discussed. An example is shown in Figure 3d. The chip which has been removed ($\sim 4\mu$ dia) is quite small compared with the approximate calculated contact diameter. For a corner oriented impact with an angular particle the contact area would be smaller and the stresses would be greater.
